EVOLUTION SPORTSTER CAM GEAR NOISE

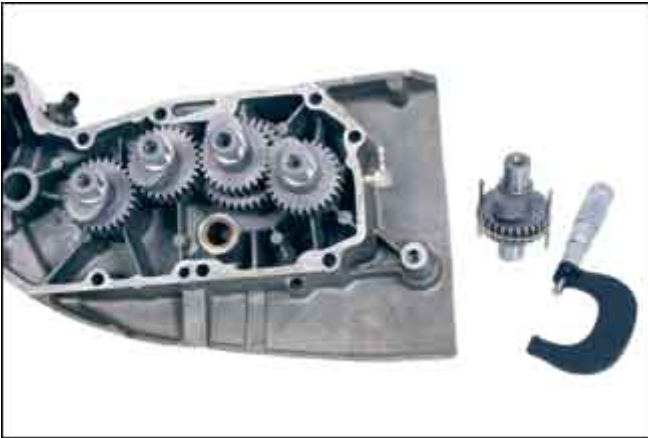
1. Install all 4 cam gears in cover (see photo) for trial fit.
2. Manually turn all four gears and verify that they roll freely. If there is no
